Manhole Inspection Summary

Manhole # S39AA1011MH

Insp Date: **9/25/08 10:22 AM**

Location Address: **751 MERVILLE AVE** Cross Street: **ELLERSLIE AVE**

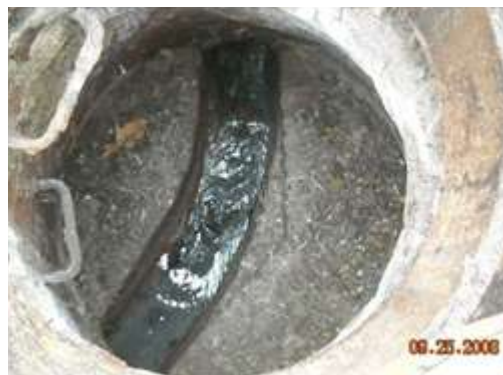
Top View

Corroded steps. Evidence of surcharge - Bench debris.

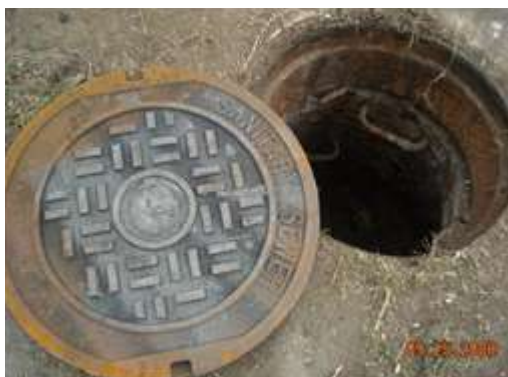
Replacement cover

Manhole Type: **Inline** Location: **Alley** Ground Conditions: **Dry**
☐ Prev. Rehab Weather: **Dry** Subject To Ponding: **Sheeting**
Comments **REI/DRAYCO VISIT 9/22/08 EXPOSED MANHOLE; CRACKED LID IN OPENNING ATTEMPT. BROKE AND REPLACED COVER (water tight replacement, see photos)**

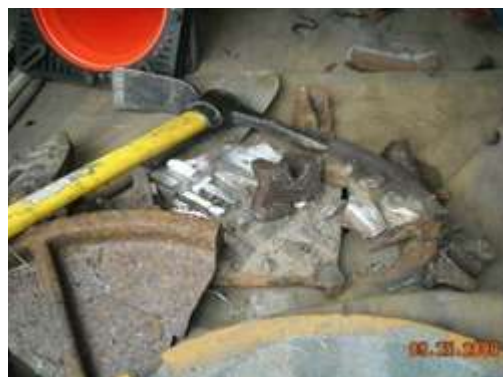
Broken cover

Broke the cover to gain access.

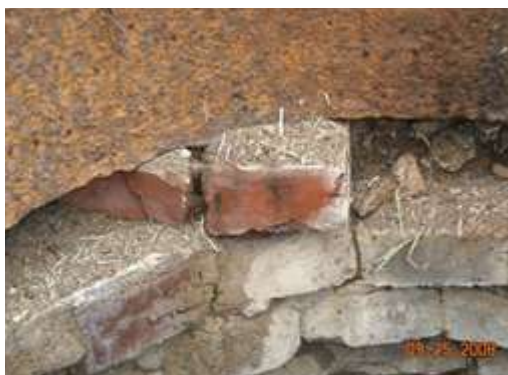
Defect

Chimney / Frame Adjustment ☒ Exists Material: **Brick** ☐ Parged Height: **3** (in.)
Condition: ☐ Sound ☐ Cracked ☐ Root Intrusion ☒ Loose Brick ☒ Deteriorated
Infiltration: ☐ None ☒ Joint ☐ Cracks ☒ Mortar ☐ Roots ☐ Wall

LOOSE CHIMNEY BRICKS

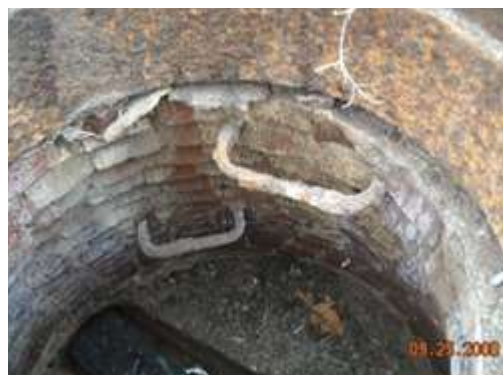
Defect

Steps Count: **2** Missing: **0** ☒ Corroded

CORRODED STEPS

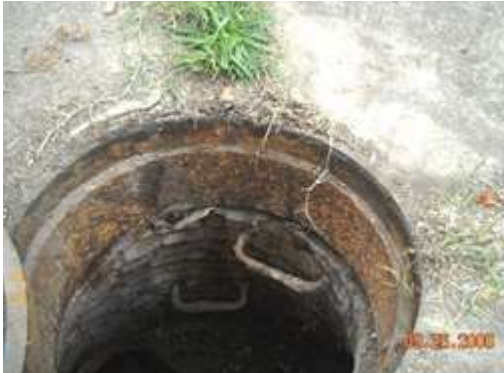
Defect

Frame offset. Adjustment deterioration, loose brick and infiltration. Corbel and Barrel infiltration.

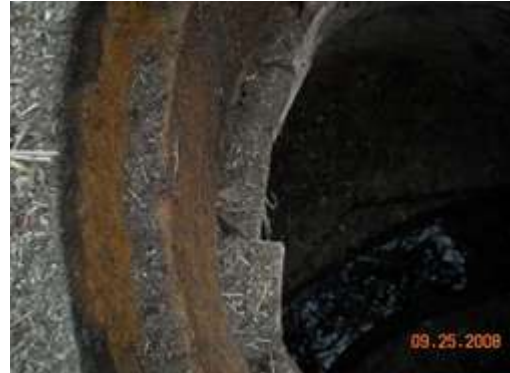
Defect

Frame offset. Adjustment deterioration, loose brick and infiltration.

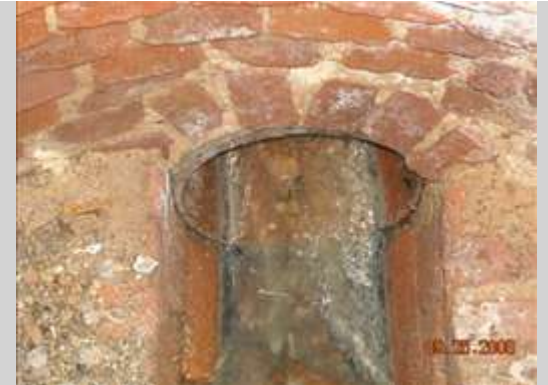
10 in. Circular Gravity Sewer Pipe Out @ 12 O'Clock

Infiltration: **Evidence** Pipe Seal Cond: **Unknown**

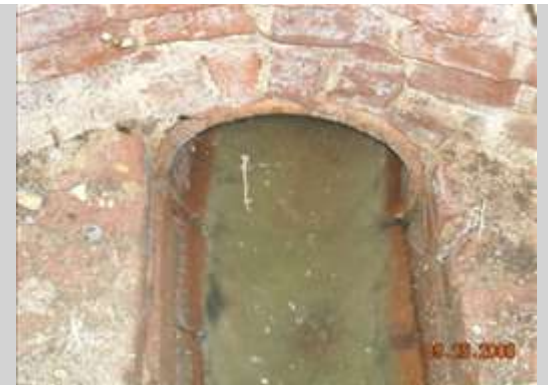
10 in. Circular Gravity Sewer Pipe In @ 7 O'Clock

Infiltration: **None** Pipe Seal Cond: **Unknown**
